# **Foel Fach Wind Farm - Environmental Statement Volume III**

Appendix 7.5: Peat Slide Risk Assessment

Project Reference: 664094

DECEMBER 2025

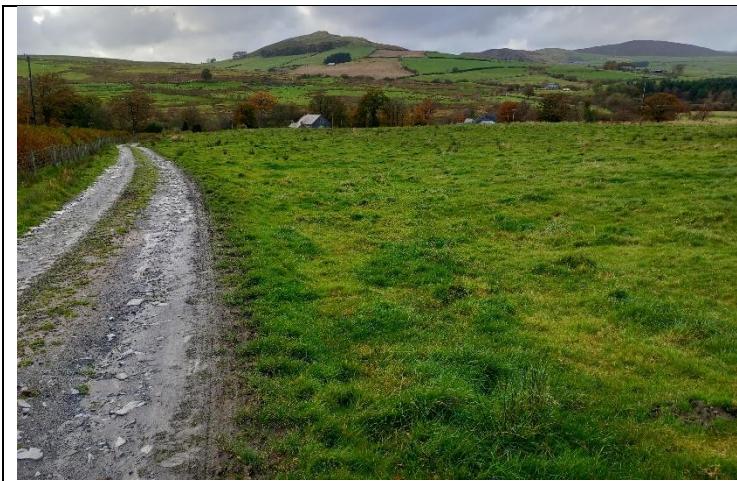
**(A) View of the existing track to the west of Llaithgwm, 29131, 34090.**

View shows the location of the proposed entrance compound to the right-hand side of the photo.

Trackside drainage is located behind the hedge on the left-hand side of the photo.

Peat soils are largely absent from this area, with coring indicating shallow clay and mineral soils.

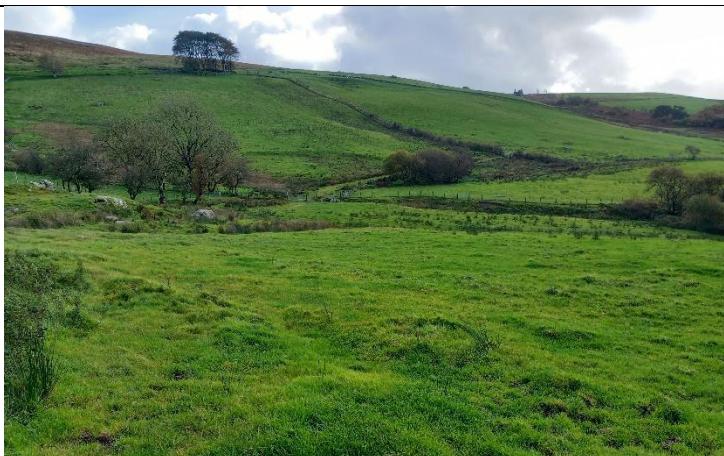
**(B) View of the fields to the south of Llaithgwm, 29212, 34095.**

The grazed fields in the western part of the Proposed Development consist of improved pasture, drained by ditches at the field margins.

No peat soils were identified in this area of the Site.

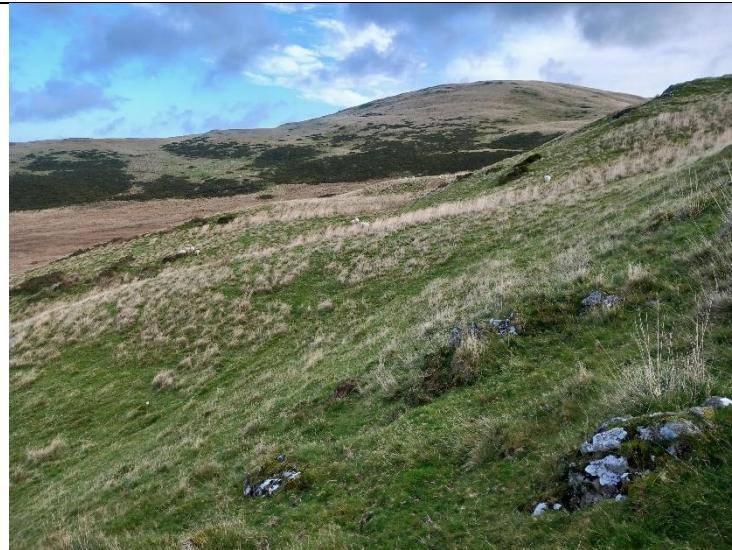
**(C) View of the hillside to the west of T02, 29316, 34137.**

Slope angles range from 15° to 25°. Bedrock is visible at the surface, and probing confirms very shallow non-peat soils. The access track is proposed to pass through this area.

An area of peatland can be seen on the left-hand side of the photo, located at the base of the hillside, where slope angles are shallow.

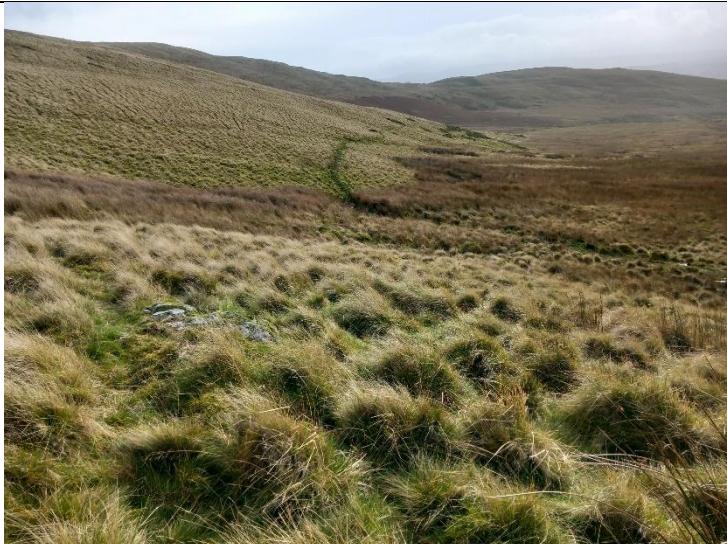
**(D) View towards the proposed T05, 29421, 34224.**

The hillside in this area is characterised by shallow soils. Bedrock is visible at the surface.

To the right-hand side of the photo, an area of peatland can be seen across the gently sloping area.

T05 is proposed on the hillside, to the left-hand side of the photo.

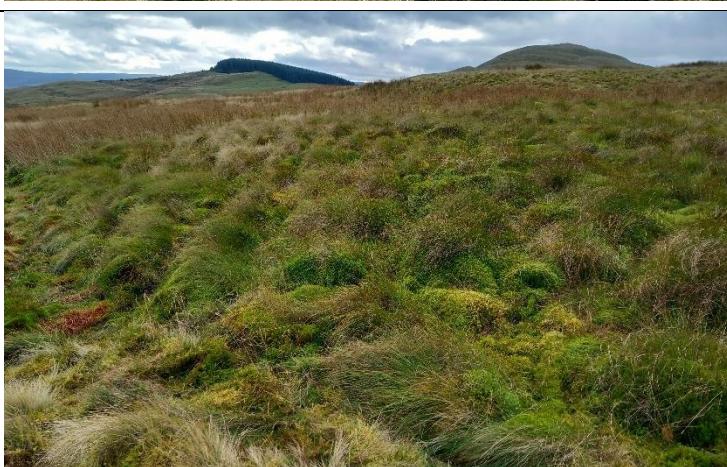
**(E) View across Foel Fâch south towards Moel Emoel, 29427, 34147.**

T07 is proposed in this area. There are limited mosses and tussocky grass. Vegetation type has evolved due to widespread grazing, this is characteristic of large areas of the Site.

There are small pockets of peat soils around the T07 hardstanding. Coring at the turbine hardstanding shows

<p>soils consist of mineral soils and clay.</p>

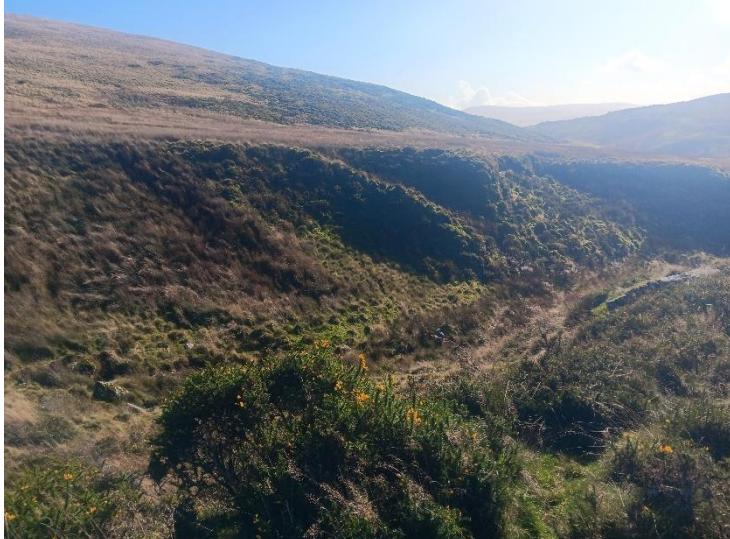
<p><b>(F) View of a tributary channel of the Nant Cefn-Coch, 29466, 34141.</b>  Soils along the watercourse channel are shallow, with bedrock visible from fluvial erosion.  Peat soils are present on the ground above the watercourse channel, although coring confirms the presence of clay at various depths underlying these deposits.  This is the location of the proposed bridge to T09 and T10.</p>

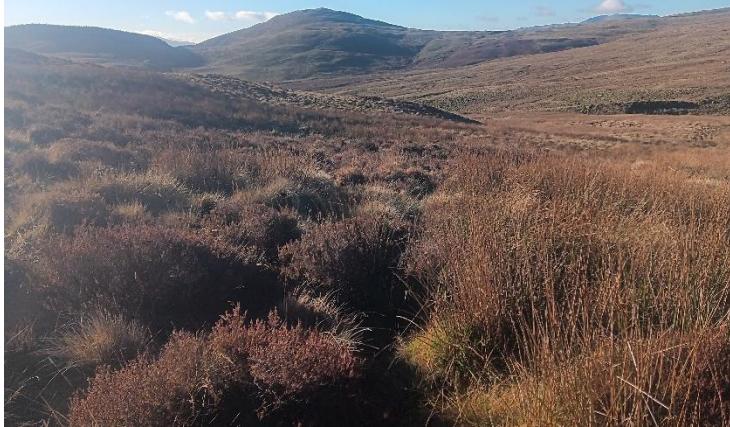
<p><b>(G) View south-west from T09, at Moel Darren, 29491, 34150.</b>  Probing and coring around the hardstanding at T09 confirmed small pockets of peat soils, of up to 1.3 m. Most of the hardstanding is underlain by clay and mineral soils.  Vegetation is predominantly heather, grass and sedges. Small areas of wetter ground, with underlying clay soils, are mainly indicated by rush vegetation.</p>

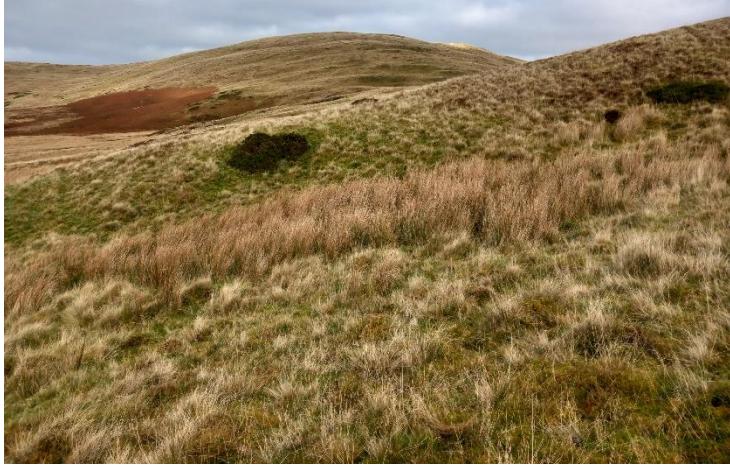
<p><b>(H) View north adjacent to the proposed track between T09 and T10, 29495, 34133.</b></p> <p>The rushes in the photo mark a small pocket of peat soil, to the west of the proposed track. The peat soil has a depth of up to 0.74 m. The surrounding vegetation is characteristic of the other grazed areas across the Site. No peat soils were identified in these surrounding areas.</p>

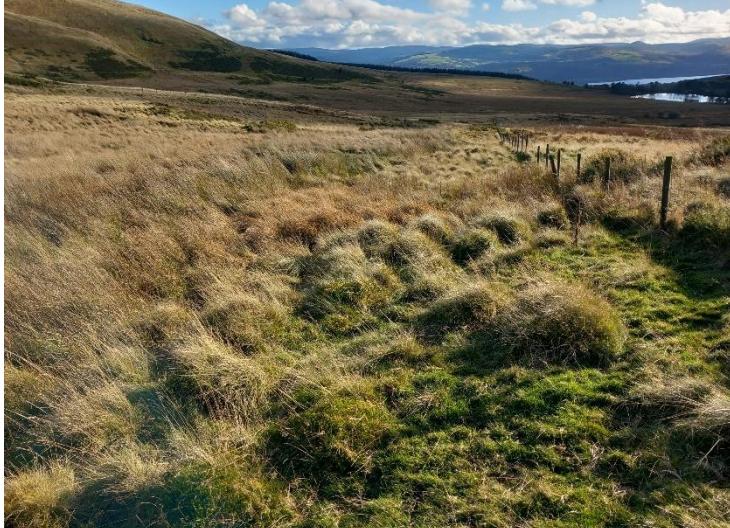
<p><b>(I) View from the area to the south of T01, 29316, 34084.</b></p> <p>This area consists of tussocky grass with a poorly defined watercourse, creating a boggy area. The watercourse drains towards Llyn Maen Bras, visible in the distance on the right-hand side of the photo. Moel Emoel is to the left-hand side of the photo. Coring identified limited pockets of peat soils, the area is typically underlain by shallow soils over clay.</p>

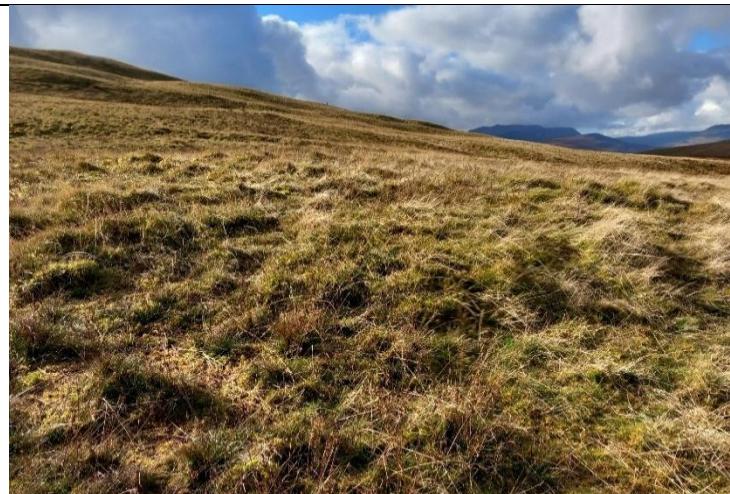
**(J) View towards the north-west slope of Moel Emoel, 29397, 34058.**

Isolated small pockets of peat soil were identified during coring and probing; however, soils are generally shallow in this area, with bedrock often visible at the surface.

The vegetation is characterised by mosses, grasses and sedges, with the area frequently grazed.

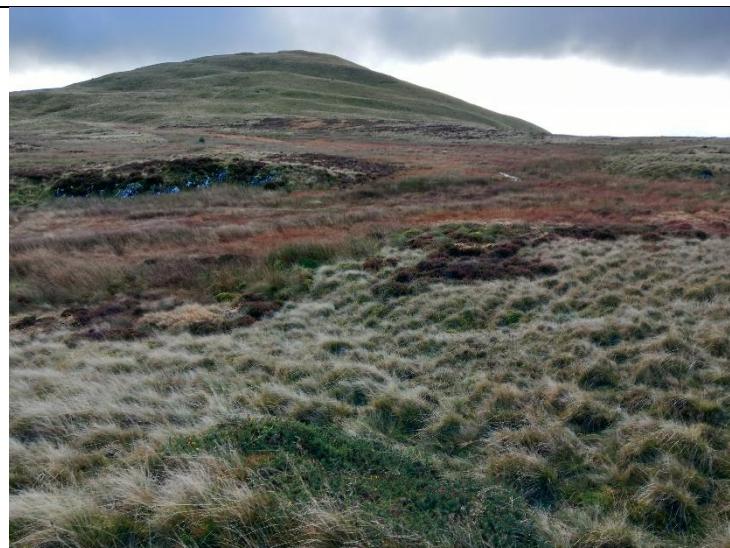
**(K) View from the area south of T03, 29369, 34086.**

The mid-ground of the photo shows an area with peat soil up to 1.15 m deep. The peat soil area is closely linked to the headwaters of a watercourse, which drains this area.

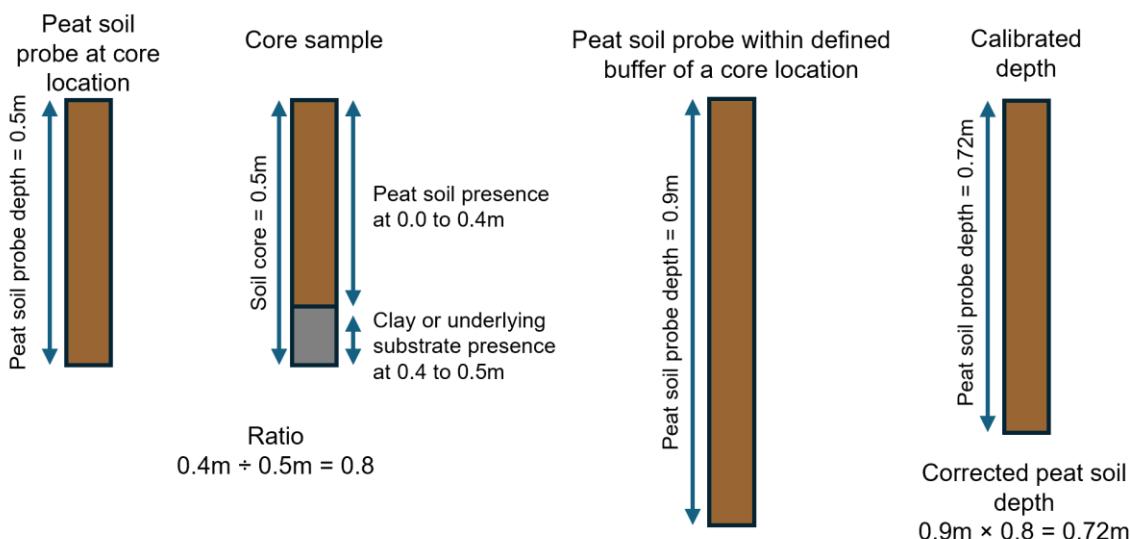
**Diagram 7.5.1 Visual Representation of an Example Peat Soil Depth Corrected to Account for the Presence of Clay Using Data from a Peat Soil Core.**

4.2.5 **Diagram 7.5.1** visually represents the calibration method used to correct the peat soil depths collected during Site surveys.

4.2.6 The decision to apply a 50 m buffer zone when calibrating probe data was made to balance the need for accurate spatial representation with the limitations of available core data. The approach aims to minimise the risk of over-correcting peat soil depth without corroborating core data. This conservative approach ensures that localised anomalies in peat soil thickness are not disproportionately applied to surrounding areas. The majority of infrastructure locations have several peat soil cores available, providing greater confidence in the representativeness of the observed peat soil depth and supporting the spatial application of the calibration ratio.

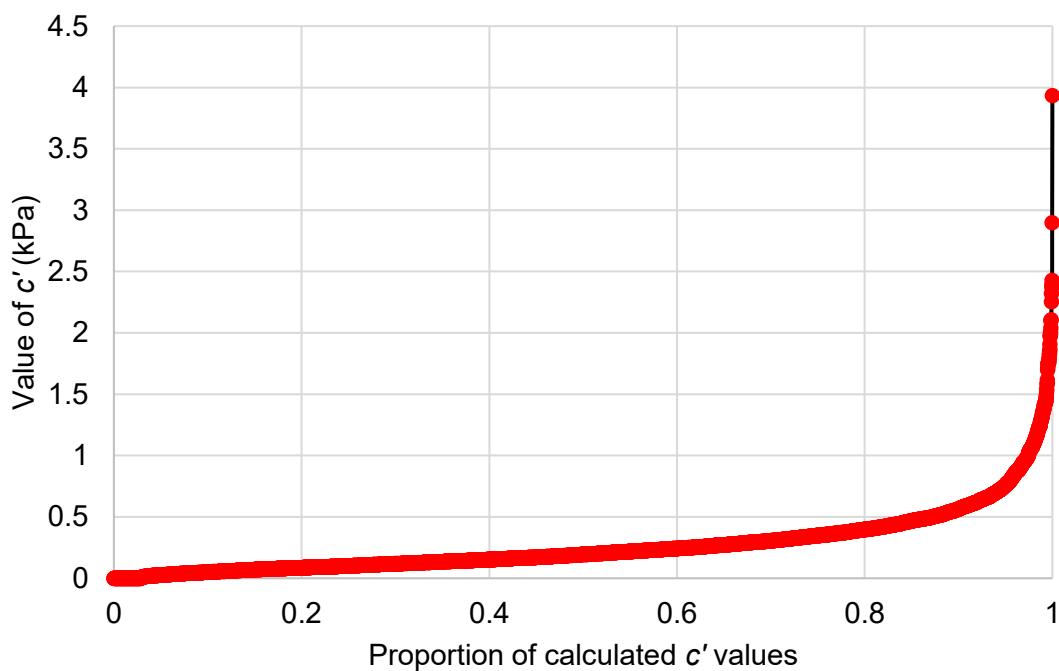
**Graph 7.5.1 Estimate of Minimum Shear Strength,  $c'$**

5.2.7 Across the Site, 5,608 locations have been probed during several phases of fieldwork.  $c'$  values have been calculated for each of these, and the distribution is provided in **Graph 7.5.1**.

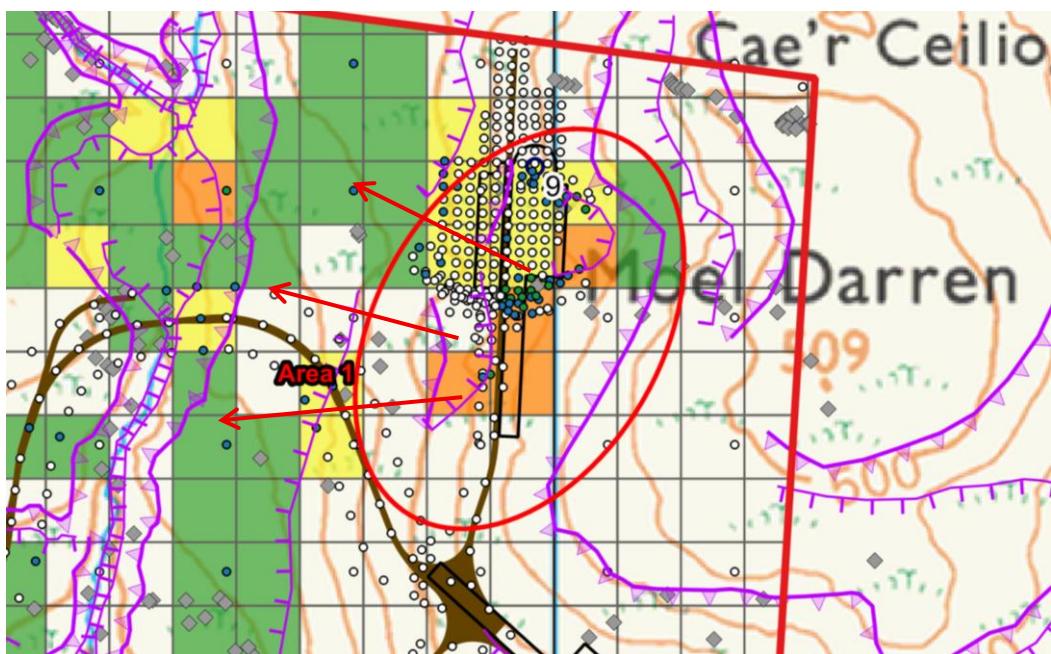
### Detailed Assessment: Area 1

Four cells located across the hardstanding at T09, in the eastern part of the Site, have been assigned Moderate risk. The assigned risk level relates to the sensitivity of the receptor, the turbine hardstanding, and its associated High consequence rating.

Calculated likelihood for the cells is Likely, reflecting the relatively steep slopes present within the cells and presence of breaks-in-slope in three of the cells. The consequence rating is High in all four cells as a result of the turbine hardstanding.

Any failure in these cells would travel west, towards an unnamed tributary of the Nant Cefn-coch. It is possible that the debris would terminate on flatter ground before reaching the channel, but some material could travel right through to the river channel. A failure could affect the integrity of the channel, may cause temporary damming of the watercourse and would be likely to cause a reduction in water quality downstream. A failure could also affect the access track section between T09 and the watercourse. Runout paths are indicated by arrows.

Very limited peat soil was identified upslope of the highlighted cells. Together with the presence of exposed bedrock, this makes it unlikely that soils upslope would be destabilised in the event of a failure.

Work in the area will require excavation to form the hardstanding and foundation for T09. The work would be under the supervision of the Environmental Clerk of Works (ECoW) at all times. Micrositing of infrastructure away from areas of peat soil deeper than 1 m would be undertaken if possible, on recommendation by the ECoW and based on prevailing site conditions and engineering constraints.

Visual monitoring of the surrounding ground would be recommended. Daily monitoring for any signs of developing instability, such as cracking or compression ridge development, would be advised for works within the highlighted risk area or within 500 m of it. Should any concerns arise, consultation would be held with a geotechnical specialist before work recommenced. Good construction methods would be used at all times, following current guidance, and no peat soil or topsoil material would be stored in this area.

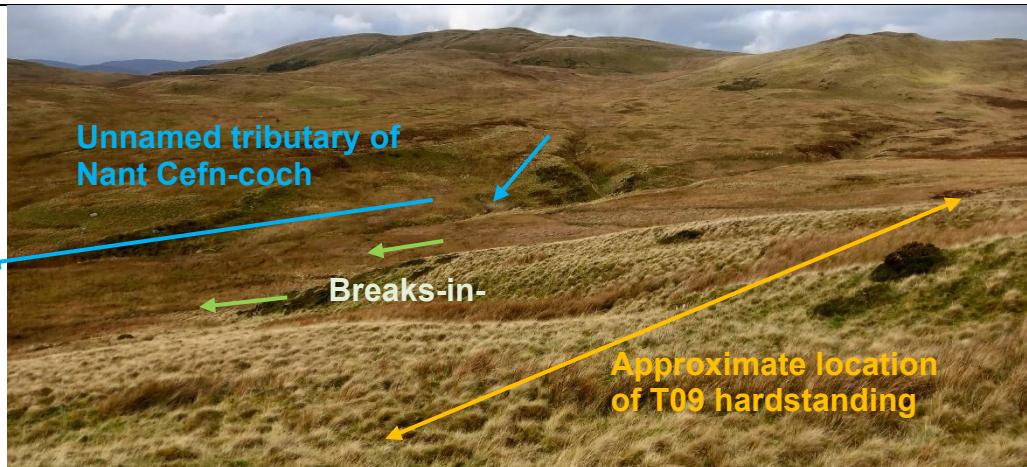
Photograph showing the southern part of Area 1, with the channel of the Unnamed tributary of Nant Cefn-coch visible in the mid-ground. The breaks-in-slope downslope from the T09 hardstanding are visible due to the change in vegetation.

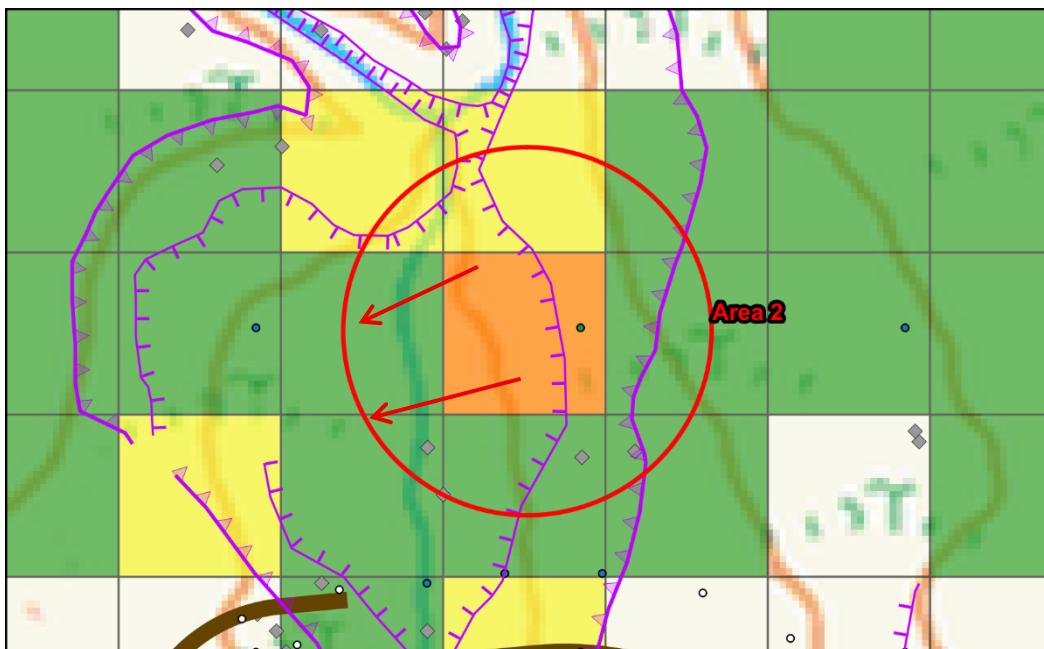
### Detailed Assessment: Area 2

One cell located to the north of the proposed watercourse crossing across the unnamed tributary to the Nant Cefn-coch, in the eastern part of the Site, has been assigned Moderate risk. The assigned risk level relates to the sensitivity of the watercourse receptor and its associated High consequence rating.

Calculated likelihood for the cell is Likely, reflecting the steep slopes and breaks-in-slope present within the cell which are associated with the incised watercourse channel. The consequence rating is High in the cell as a result of the watercourse sensitivity.

Any failure in this cell would travel west, terminating in the unnamed tributary of Nant Cefn-coch. A failure could affect the integrity of the channel, may cause temporary damming of the watercourse and would be likely to cause a reduction in water quality downstream. A substantial failure could affect the integrity of the bridge crossing, although this is unlikely. Runout paths are indicated by arrows.

Limited peat soil was identified upslope of the highlighted cell and the presence of exposed bedrock further reduces the likelihood of soils upslope of the highlighted cell being destabilised during a failure.

No signs of instability or potential instability were observed in this area. It is clear from the measured peat soil depths that peat soil coverage is variable in this area, including sections with no peat soil presence and small isolated pockets of peat soil in some areas. The areas with the steeper slopes and the areas with peat soil are not coincident and, therefore, it is considered that the model used has over-estimated the risk at this location.

All construction works in this area would be under the supervision of the ECoW at all times. Visual monitoring of the watercourses and intervening ground would be recommended between the location of the temporary bridge working area and the highlighted risk cell. Daily monitoring for any signs of developing instability, such as cracking or compression ridge development, would be advised for works within the highlighted risk area or within 500 m of it. Should any concerns arise, consultation would be held with a geotechnical specialist before work recommenced. Good construction methods would be used at all times, following current guidance, and no peat soil or topsoil material would be stored in this area.

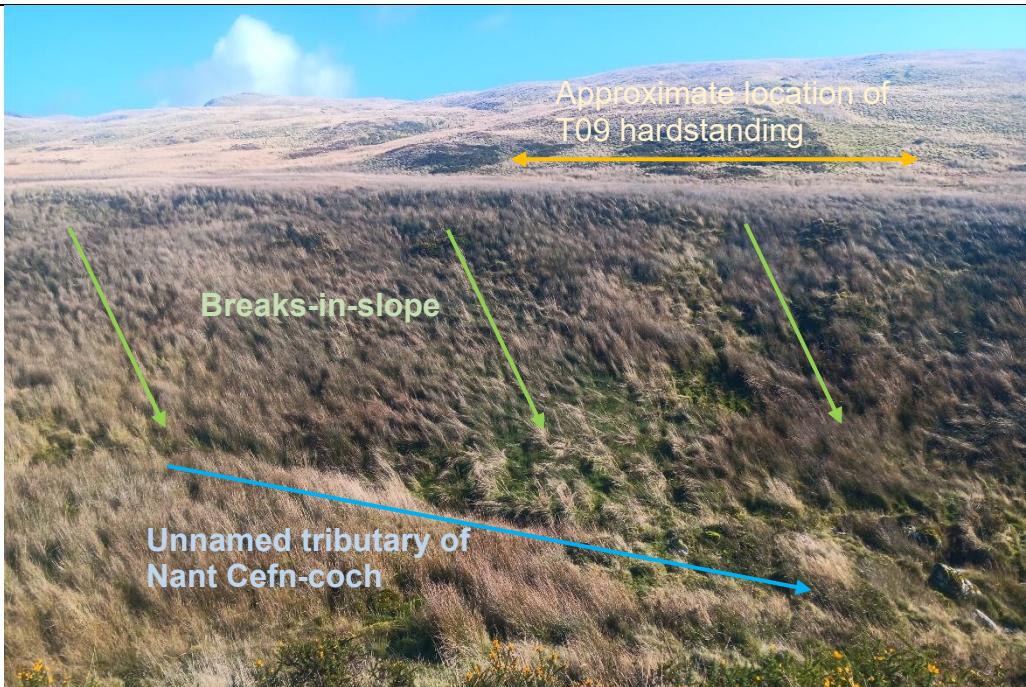
Photograph looking towards Area 2. The breaks-in-slope associated with the channel of the Unnamed tributary of Nant Cefn-coch are visible. The hardstanding for T09 is located on the slope beyond the flat area of ground above the watercourse channel.

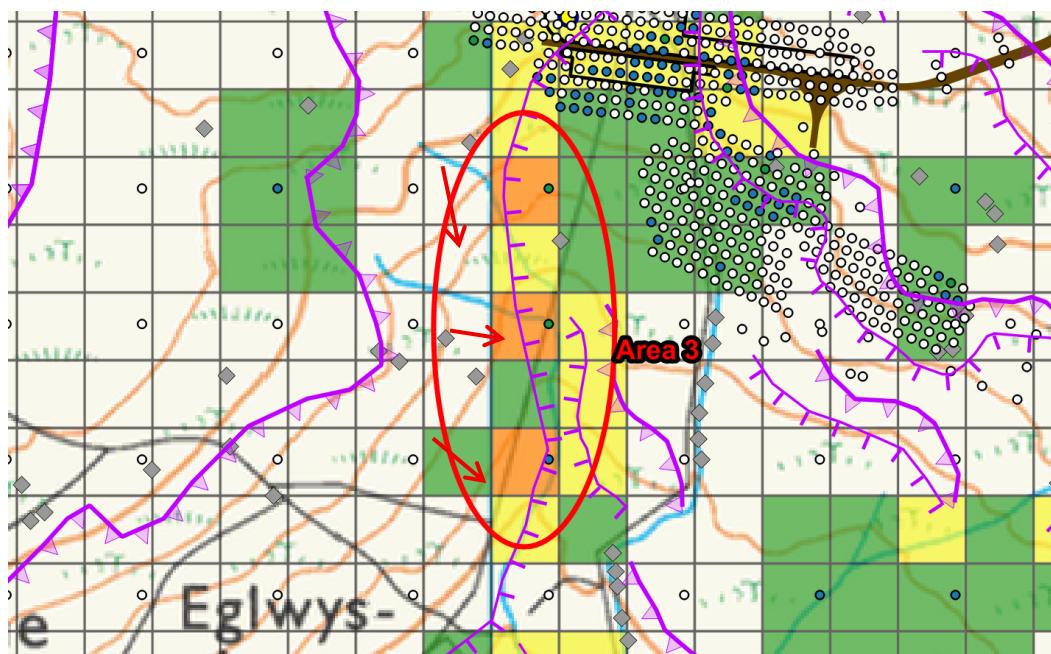
### Detailed Assessment: Area 3

Three cells located to the south of T01, in the western part of the Site, have been assigned Moderate risk. The assigned risk level relates to the sensitivity of the watercourse receptor, and its associated High consequence rating.

Calculated likelihood for the cell is Likely, reflecting the breaks-in-slope present within the cells which are associated with the watercourse channel. The consequence rating is High in the cells as a result of the watercourse's sensitivity.

Any failure in these cells would travel east and south, terminating in the unnamed watercourse which flows towards Llyn Maen Bras. A failure could affect the integrity of the channel, may cause temporary damming of the watercourse and would be likely to cause a reduction in water quality downstream. Runout paths are indicated by arrows.

Limited peat soil was identified upslope of the highlighted cell and the presence of exposed bedrock further reduces the likelihood of soils upslope of the highlighted cell being destabilised during a failure.

No signs of instability or potential instability were observed in this area. It is clear from the measured peat soil depths that peat soil coverage is highly variable in this area, including sections with no peat soil presence and others with small isolated pockets of peat soil in areas adjacent to watercourses. The areas with the steeper slopes and the areas with peat soil are not coincident and, therefore, it is considered that the model used has over-estimated the risk at this location.

All construction works in this area would be under the supervision of the ECoW at all times. Visual monitoring of the watercourses and intervening ground would be recommended between the location of T01 and the highlighted risk cells. Vehicle tracking into the highlighted area would not be permitted for any reason. Daily monitoring for any signs of developing instability, such as cracking or compression ridge development, would be advised for works within the highlighted risk area or within 500 m of it. Should any concerns arise, consultation would be held with a geotechnical specialist before work recommenced. Good construction methods would be used at all times, following current guidance, and no peat soil or topsoil material would be stored in this area.

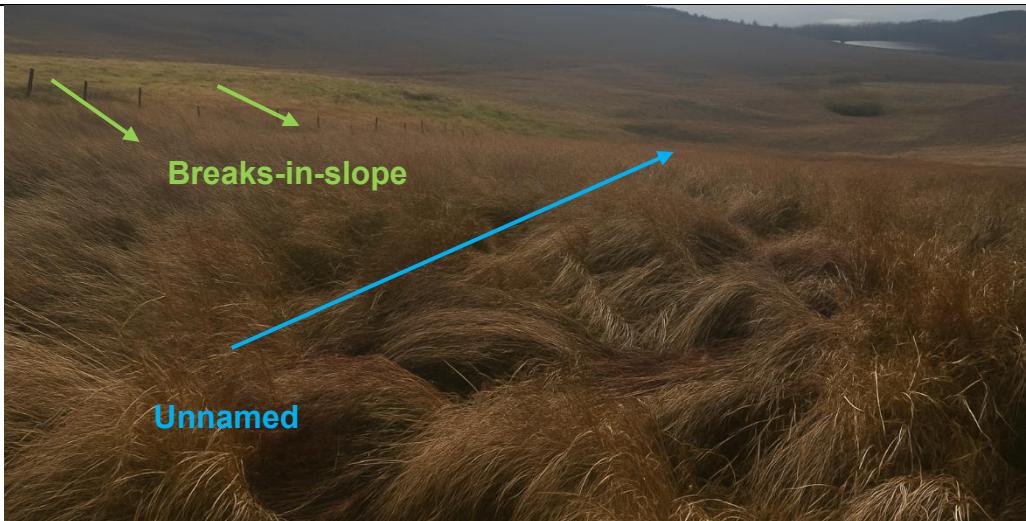
Photograph looking towards Area 3. The breaks-in-slope associated with the channel of the unnamed watercourse are visible.
